Accelerated fatigue testing of LM 19.1 blades

Citation (APA):
Kristensen, O. J. D., & Jørgensen, E. (2003). *Accelerated fatigue testing of LM 19.1 blades*. Denmark. Forskningscenter Risoe. Risoe-R No. 1358(EN)

Accelerated Fatigue Testing of LM 19.1 Blades

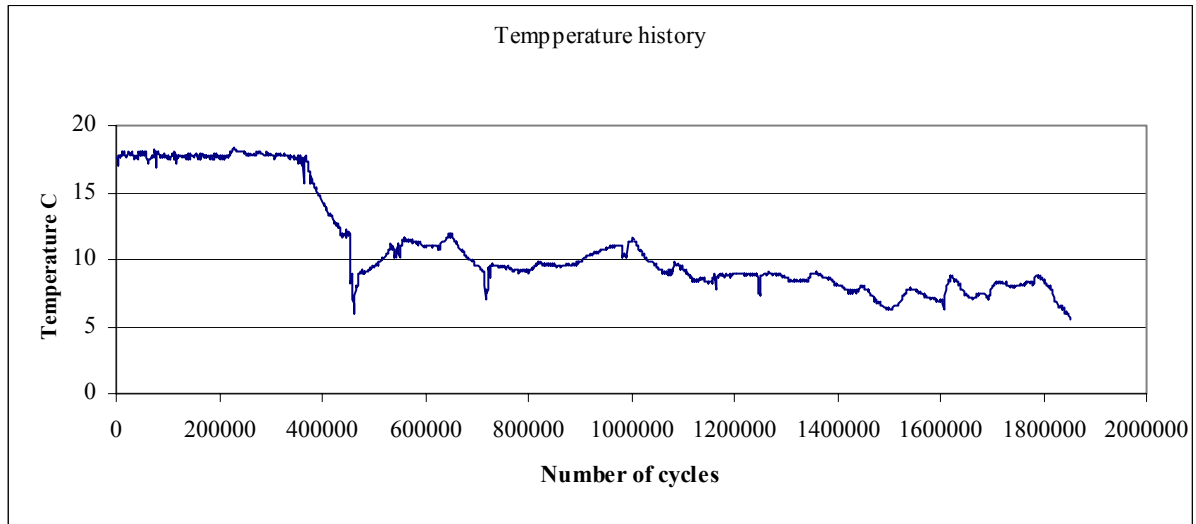
Figure 45. Temperature measurements during flapwise fatigue test.

Through the flapwise fatigue test temperature measurements were made. Figure 45 shows the temperature in the environment as a function of the cycles. The data-acquisition-computer measured the temperature and number of cycles.

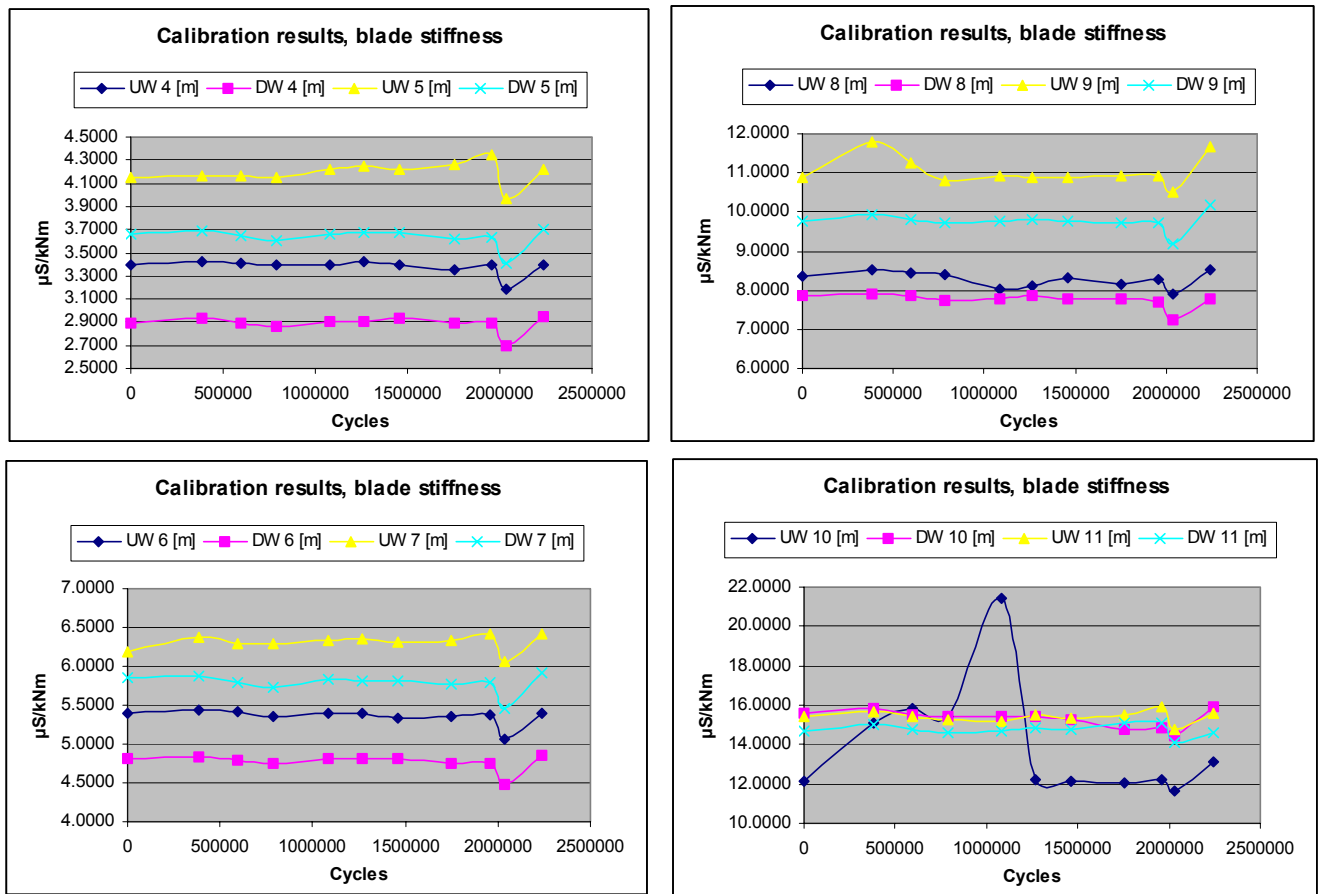
Figure 46. Discrete stiffness distribution for calibration tests of LM 19.1 # 4700, the x-axis is number of cycles applied to the blade

During the fatigue test several calibration tests were performed. The calibration tests were performed as static tests with load applied to make bending towards suction (down wind) side of blade. Figure 46 shows the normative stiffness of the blade for discrete sections of the blade. The measurements show the $\mu\text{S/kNm}$ local stiffness at maximum load for the calibration tests. The graphs are supposed to be linear i.e no change in stiffness of the blade. The graphs show no change in stiffness for the different sections of the blade. The change seen on the UW 10 [m] in the early stage of the test is caused by a defect strain gauges.

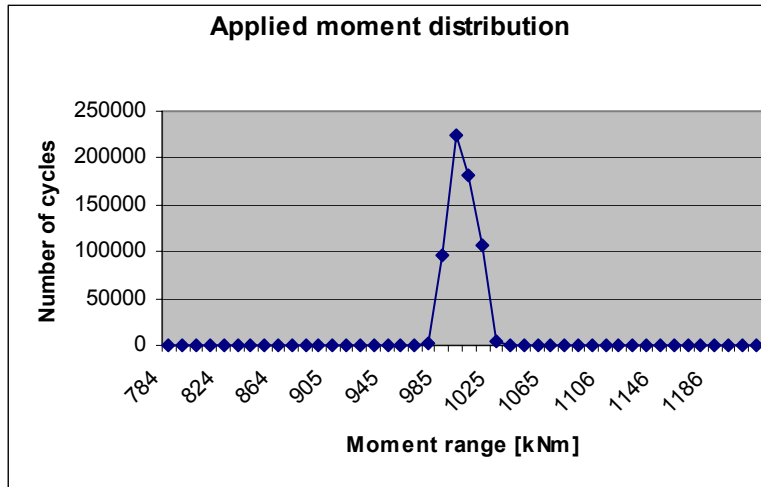
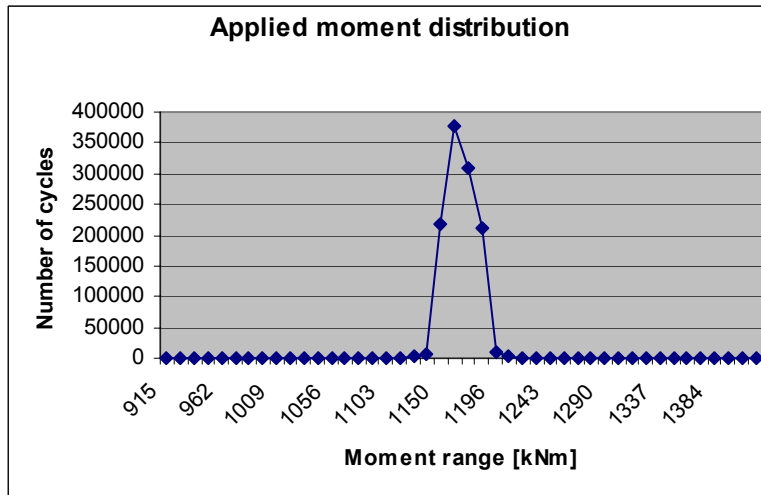
Figure 47. Moment distribution for blade # 4700 at load level 1

Figure 48. Moment distribution for blade # 4700 at load level 2

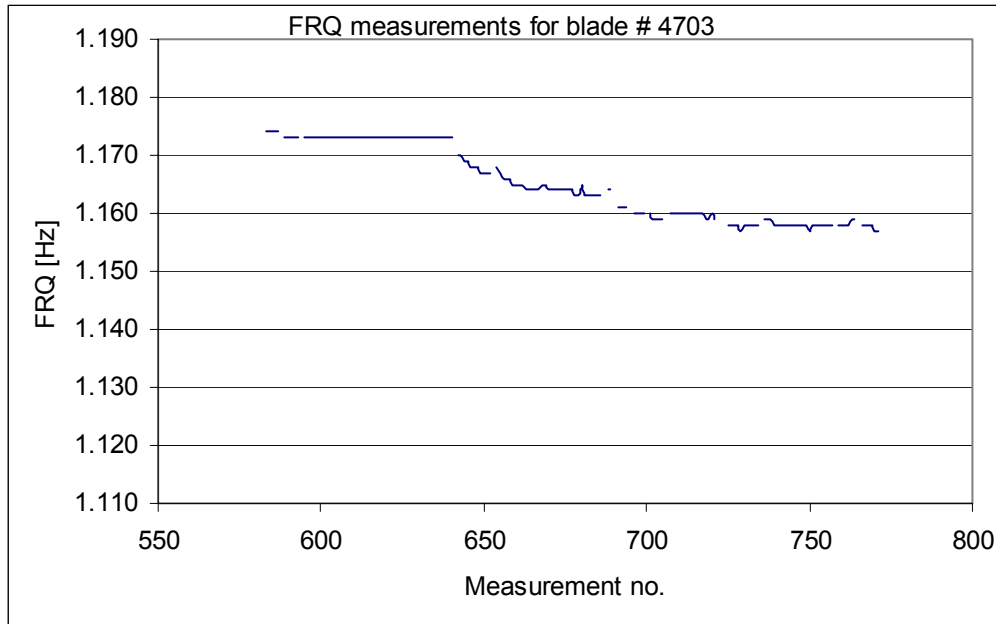
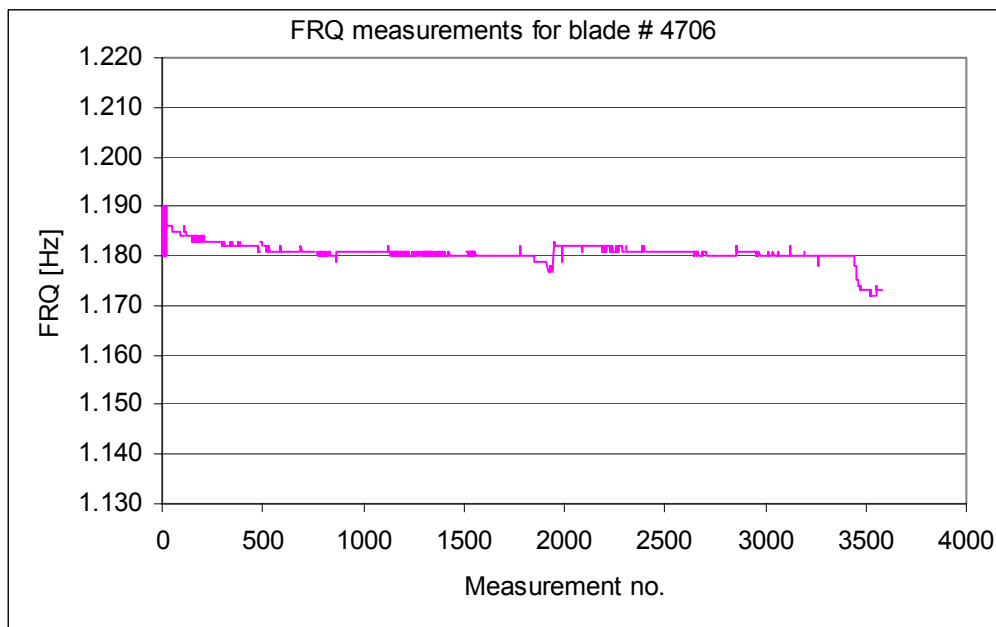
Figure 49. Changes in natural frequency (1st flapwise bending mode) as the tests proceeded.

The natural frequency (1st flapwise bending mode) was measured on the three blades during the fatigue tests. Changes in the stiffness of the blade will influence on the natural frequencies, and this is seen as changes in the structure.

As the graphs showed a general decrease in the frequency of the blades as the fatigue tests proceeded were observed.

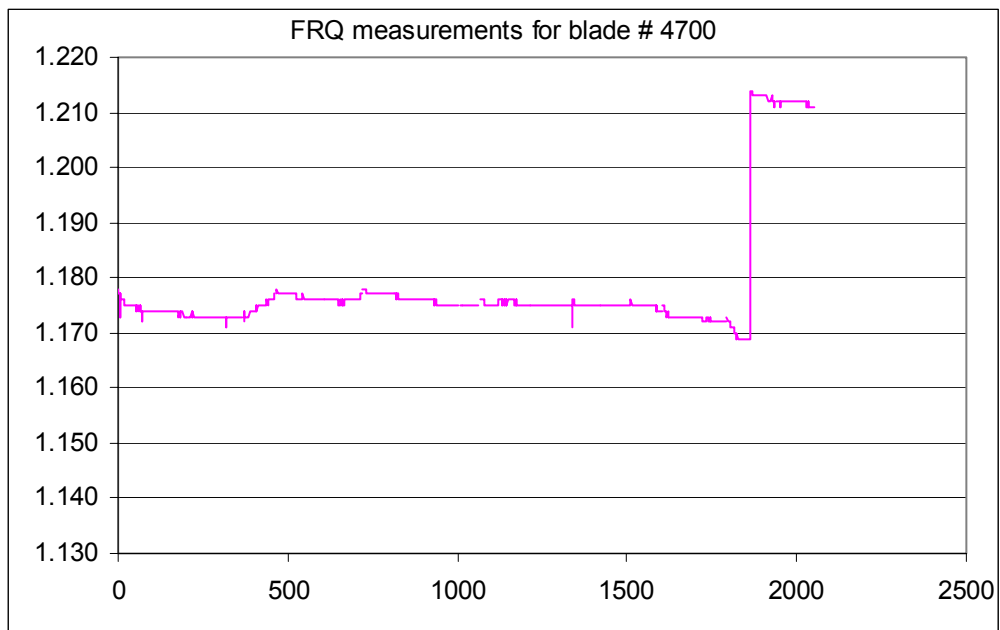
Figure 50. Changes in natural frequency (1^{st} flapwise bending mode) as the test proceeded.

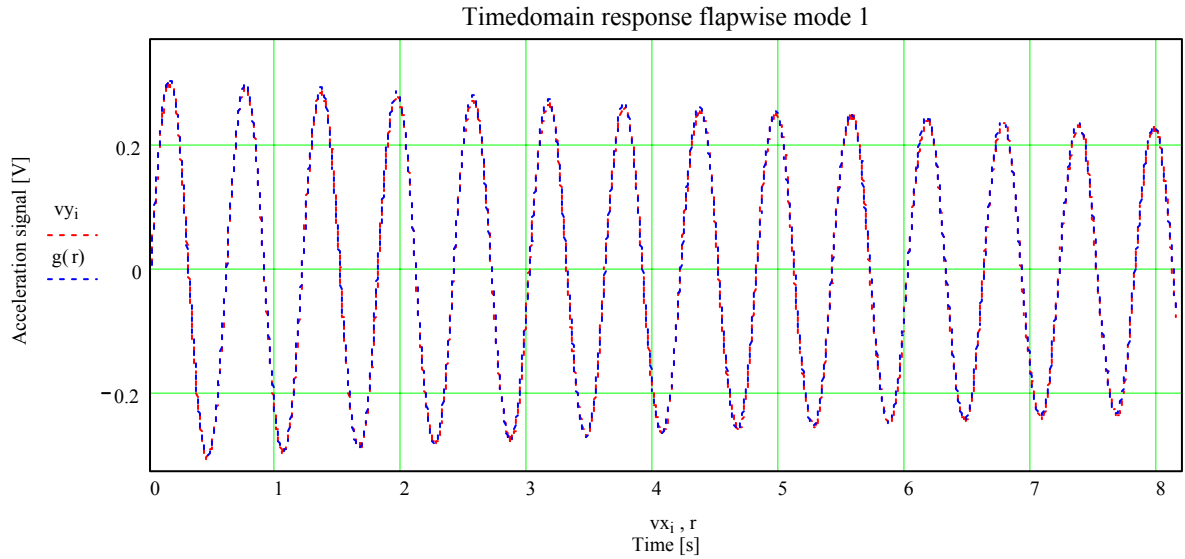
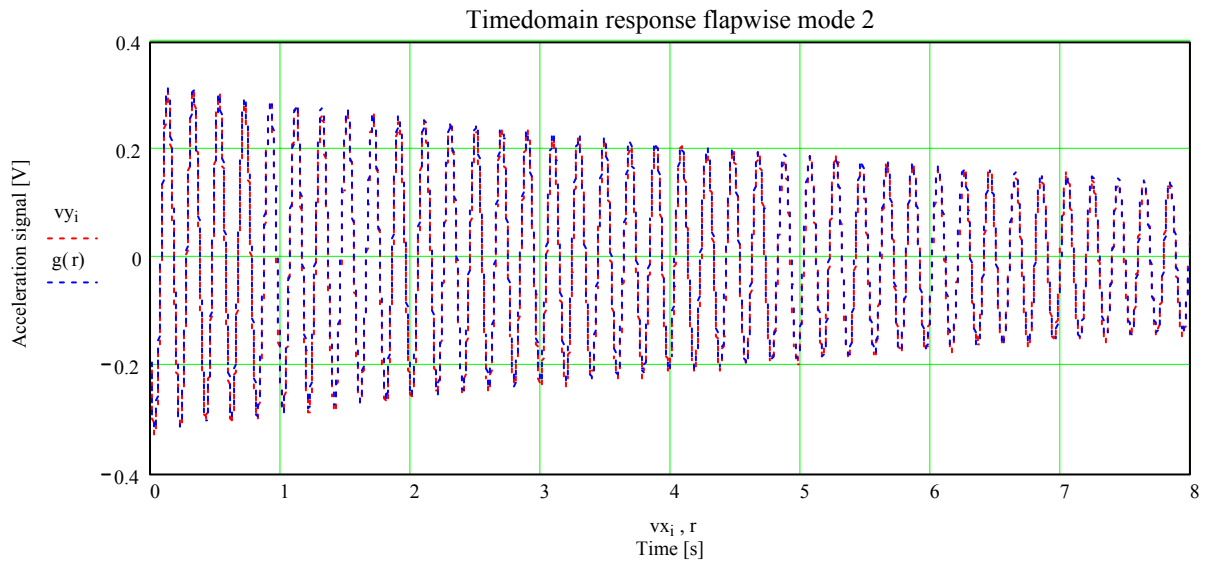
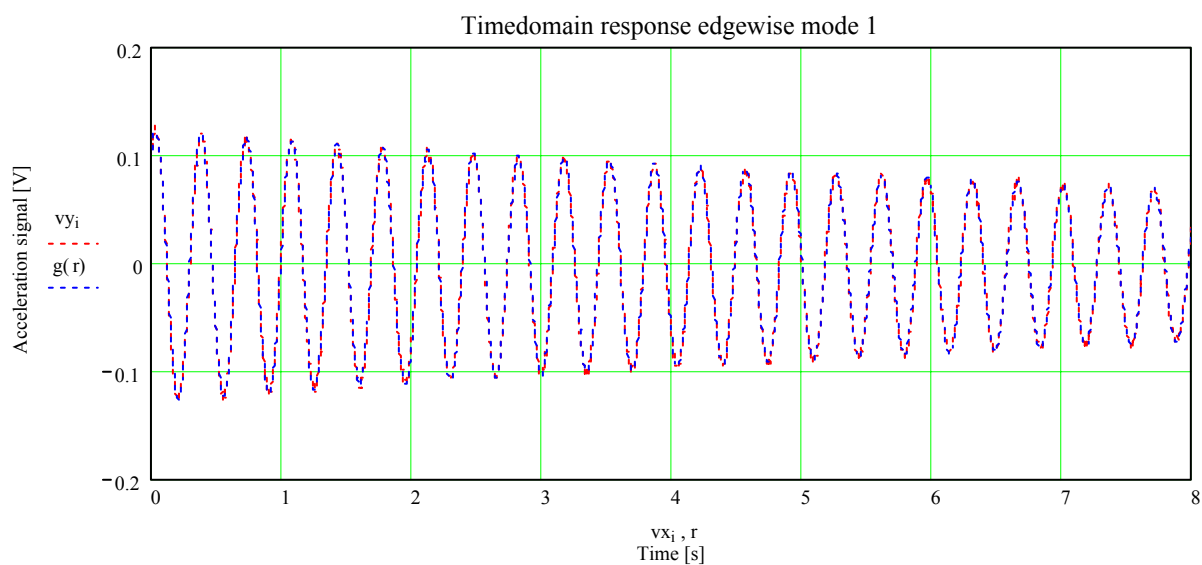
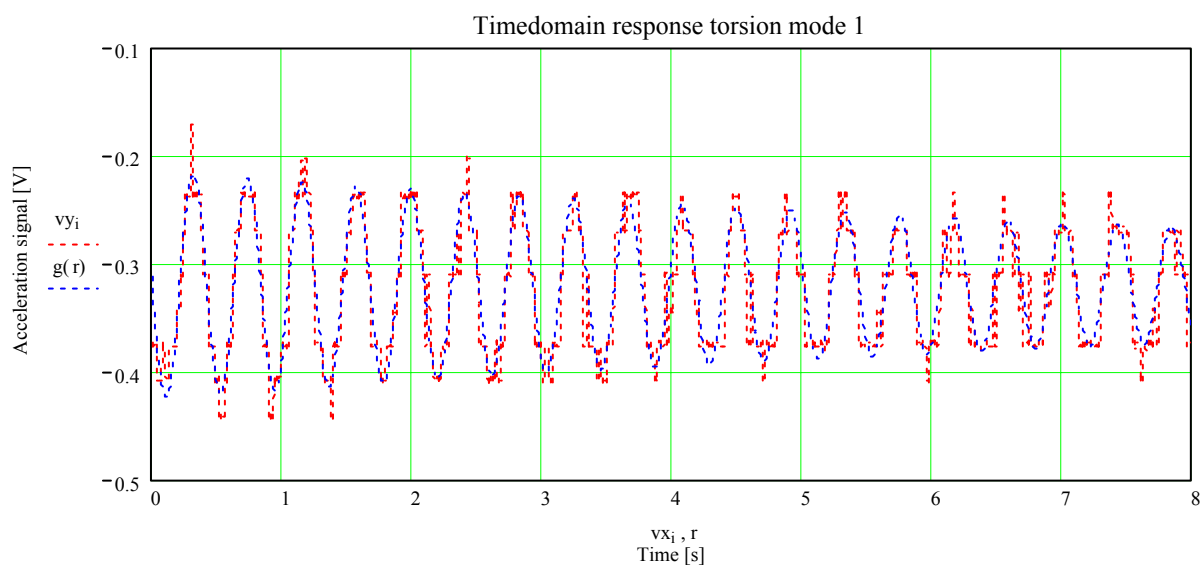
LM 19.1 # 4703 frequency graphs

Figure 51. Time domain response, flapwise 1. mode.

Figure 52. Time domain response, flapwise 2. mode.

Figure 53. Time domain response, edgewise 1. mode

Figure 54. Time domain response, torsional 1. Mode. The figure shows the torsional frequency replayed in a speed of 1/10 of the normal speed.

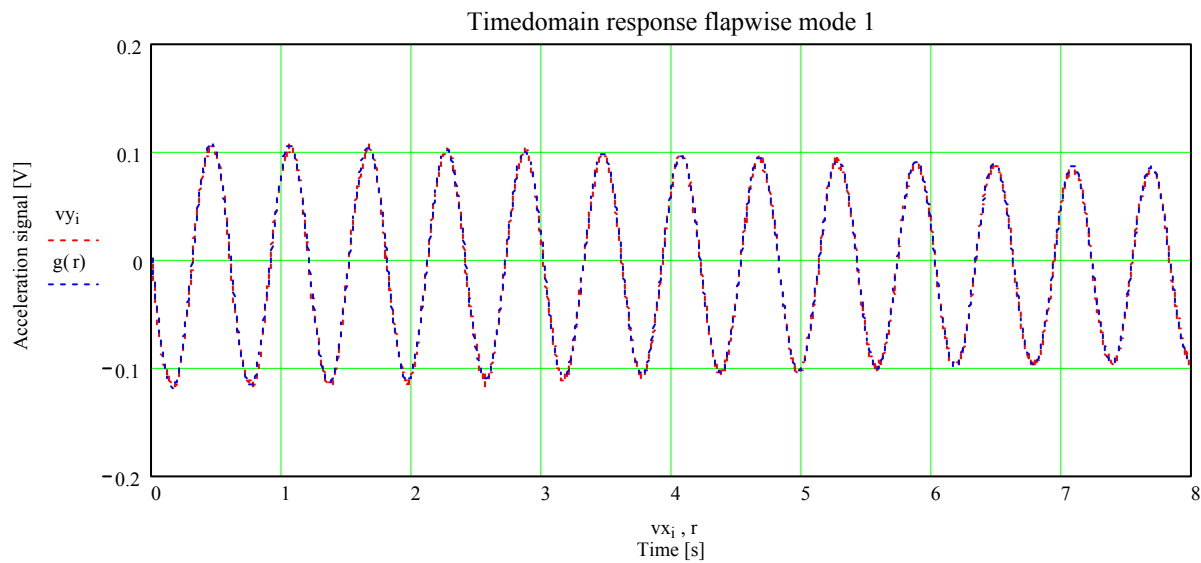
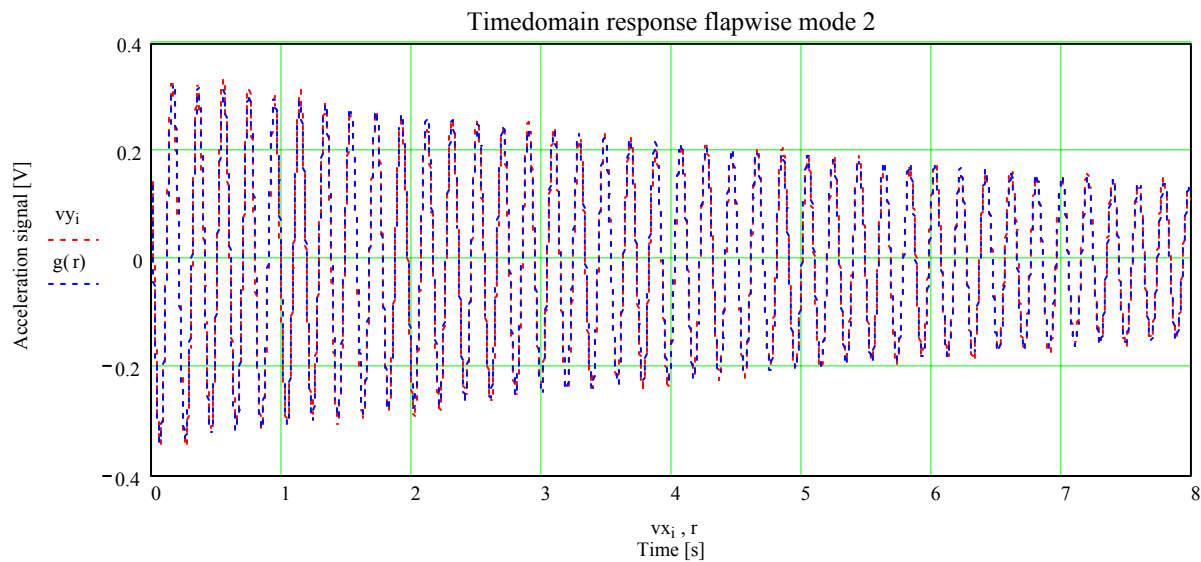
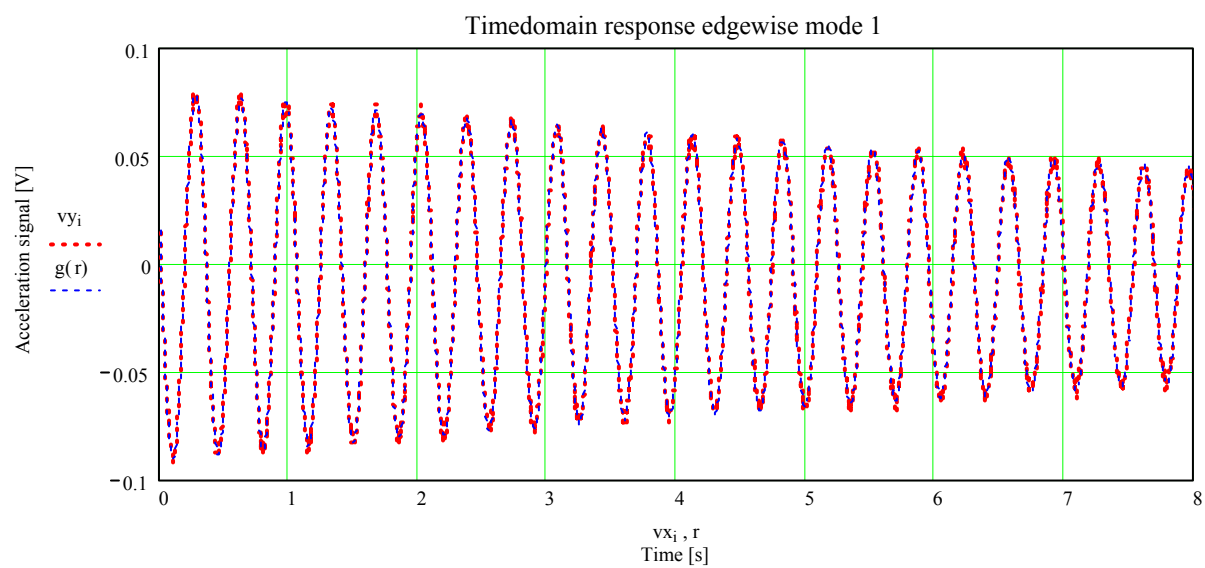
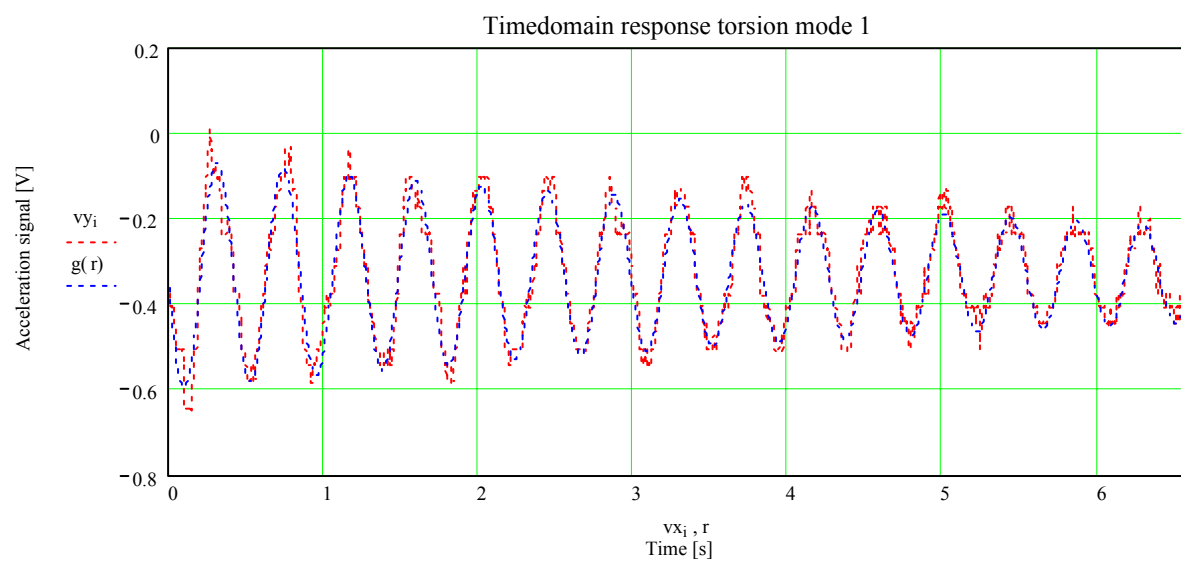
LM 19.1 # 4706 frequency graphs

Figure 55. Time domain response, flapwise 1. mode.

Figure 56. Time domain response, flapwise 2. mode.

Figure 57. Time domain response, edgewise 1. mode

Figure 58. Time domain response, torsional 1. Mode. The figure shows the torsional frequency replayed in a speed of 1/10 of the normal speed.

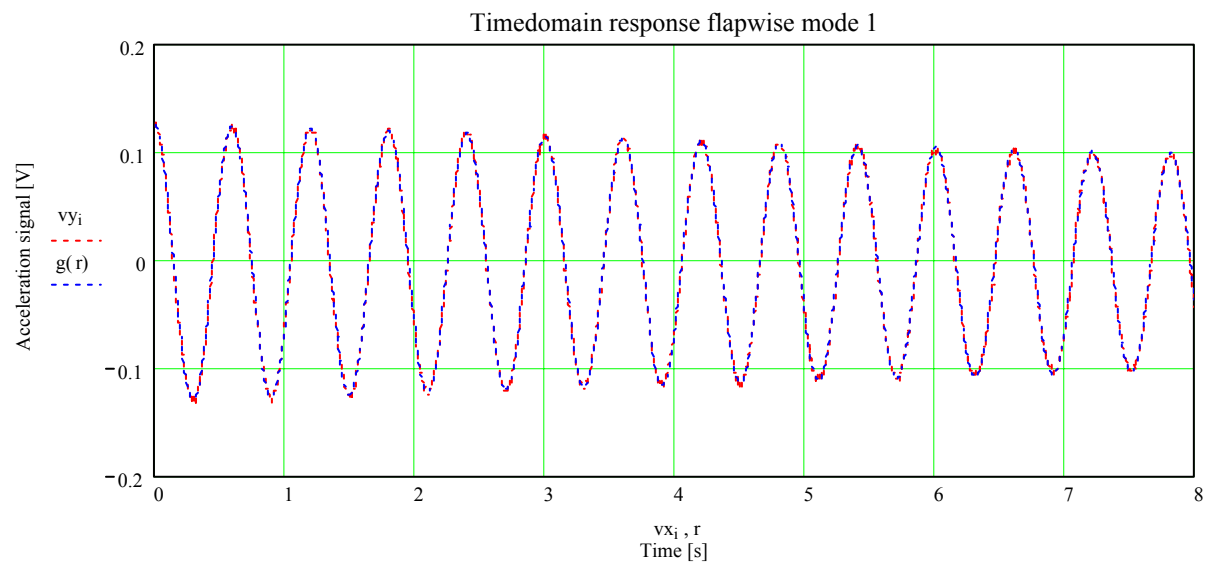
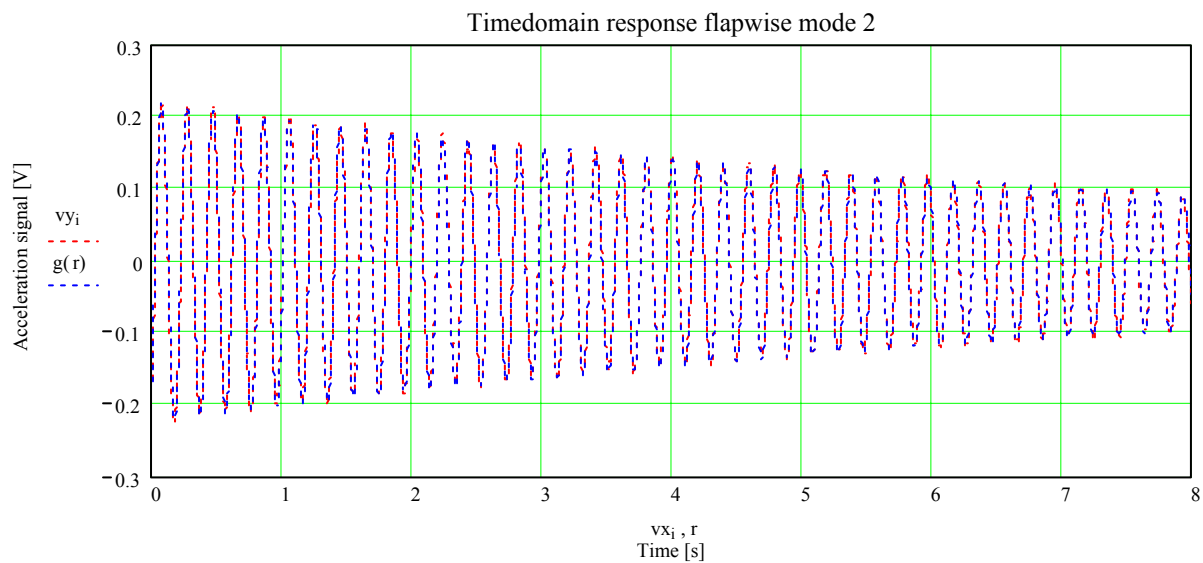
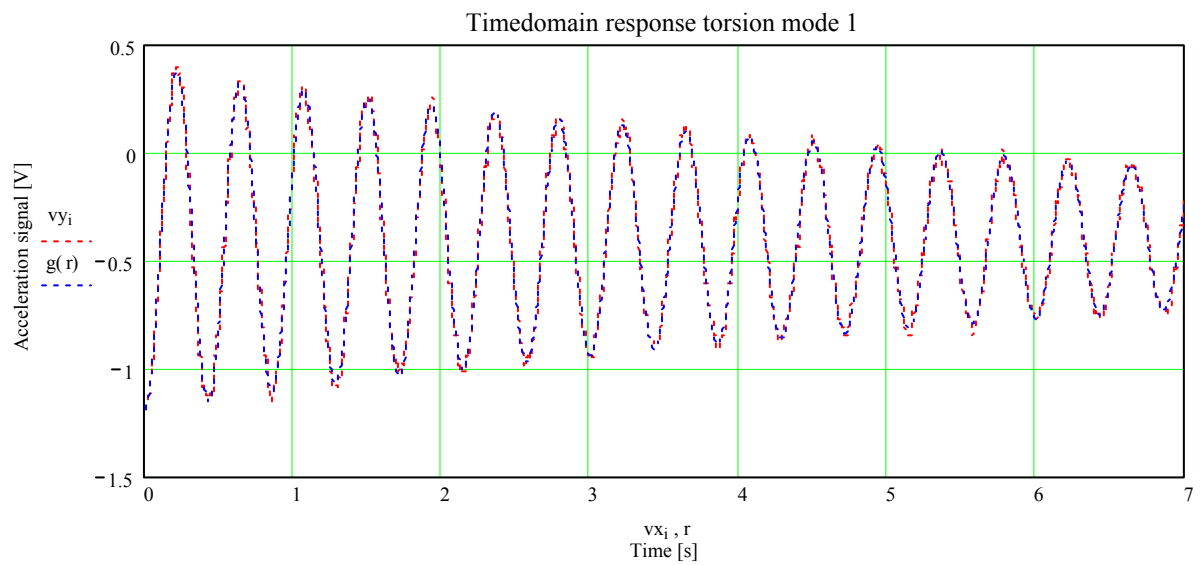
LM 19.1 # 4700 frequency graphs

Figure 59. Time domain response, flapwise 1. mode.

Figure 60. Time domain response, flapwise 2. mode.

Figure 61. Time domain response, edgewise 1. mode

Figure 62. Time domain response, torsional 1. Mode. The figure shows the torsional frequency replayed in a speed of 1/10 of the normal speed.
